Manhole Inspection Summary

Manhole # S21YY1001MH

Insp Date: **11/27/06 2:28 PM**

Location Address: **FALLS RD**

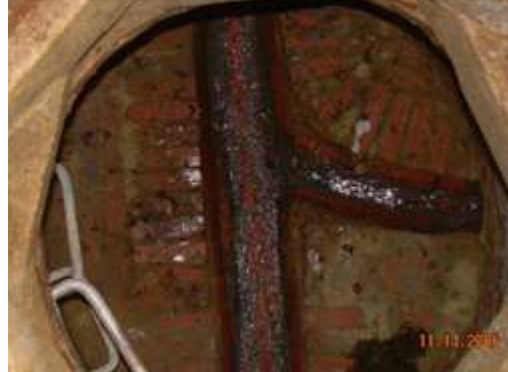
Top View

Bench debris.

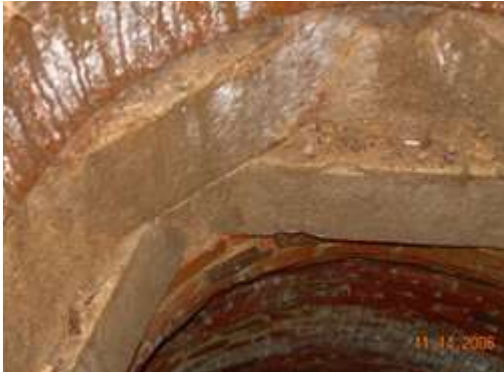
Defect

Offset: **1** (in.)

Infiltration: ☐ None ☒ **Joint** ☐ Cracks ☒ **Mortar** ☐ Roots ☐ Wall

Infiltration: ☐ None ☐ Joint ☐ Cracks ☒ **Mortar** ☐ Roots ☒ **Wall**

Frame offset. Adjustment and Barrel infiltration.

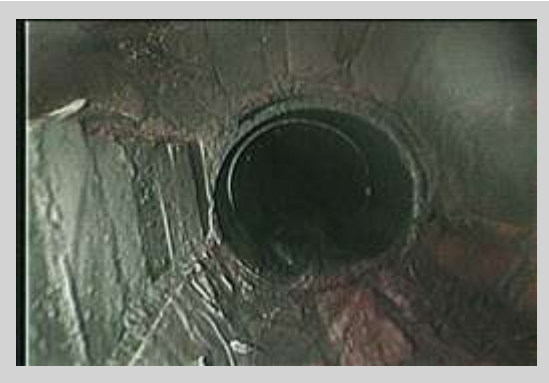
8 in. Circular Gravity Sewer Pipe Out @ 12 O'Clock

Infiltration: **Evidence** Pipe Seal Cond: **Unknown**

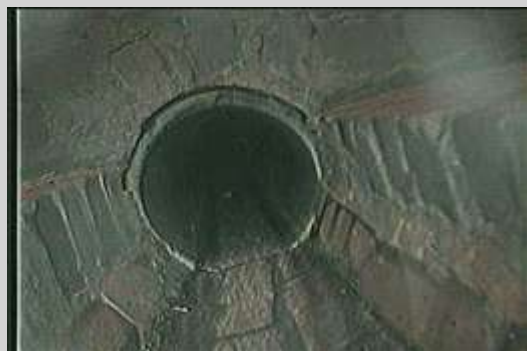
8 in. Circular Gravity Sewer

Infiltration: **Evidence**
